DOCUMENT **SEVENTY-FOURTH REPORT OF THE COURT APPOINTED RECEIVER OF PERERA SHAWNEE LTD. AND PERERA DEVELOPMENT CORPORATION**  
**DATED JANUARY 7, 2019**

**PREPARED BY DELOITTE RESTRUCTURING INC.**

# Highbury - Incomplete Work and Deficiency Review

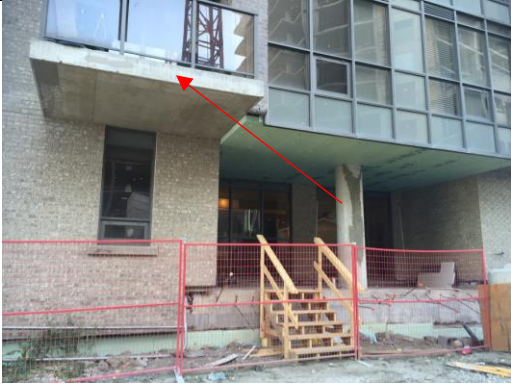
Table 1: Additional Incomplete Items Observed During The Site Tour			
Item #	Building Area	Incomplete Item Description	Photo
A1	Balconies	The majority of balcony slab edges are unfinished and require parging. To install the parging would require rigging a specialized swingstage.

<p>Photo 1: West elevation balcony slab.</p>
A2	Landscaping	The incomplete plaza has lead to visible insulation and membrane damage. No root barrier installed. The damage may be extensive, and may require complete removal and replacement of the plaza membrane.

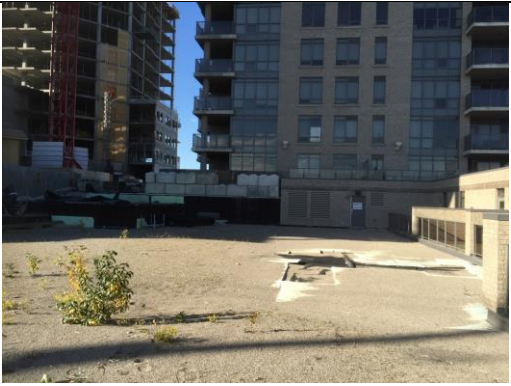
<p>Photo 2: Existing ballast and exposed insulation at the south end of west elevation.</p>

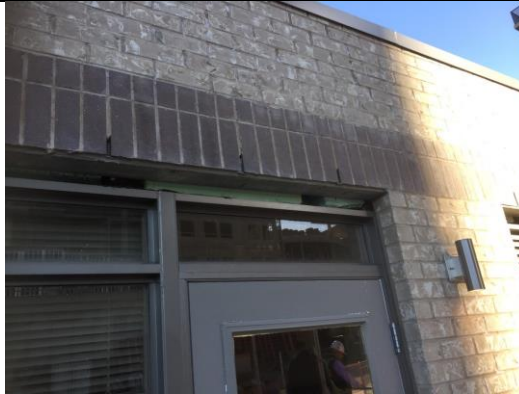
A3	Window Wall/Brick Cladding Transition	On the west elevation, north end we observed exposed insulation above the window wall frame. The perimeter joint was not sealed. Exposed insulation is not considered viable due to UV damage. Replacement requires brick removal.

<p>Photo 3: Exposed insulation between the window wall frame and brick cladding above, west elevation, north end.</p>
A4	EIFS Cladding	We observed several locations with the EIFS cladding not fully back wrapped along the base of the wall, at the penthouse level. We are not aware of any EIFS system which meets the requisite combustible material performance ratings without fully encapsulated reinforcing.

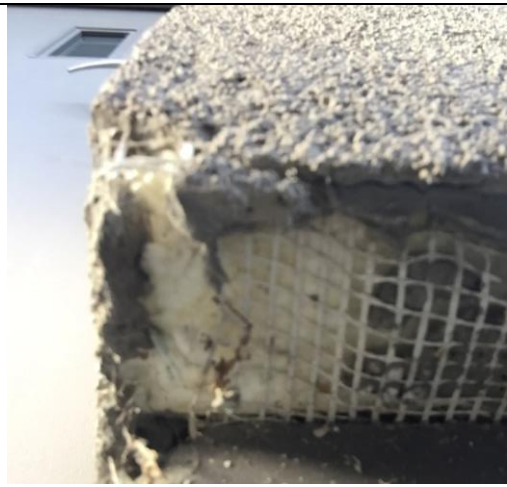
<p>Photo 4: Incomplete EIFS cladding at base of wall, at penthouse level.</p>
A5	Roof	Filter fabric was not installed at various gravel ballast roofs. Based on the architectural drawings the typical roof assembly should have a layer of filter fabric installed over the rigid insulation, before the gravel ballast is installed.

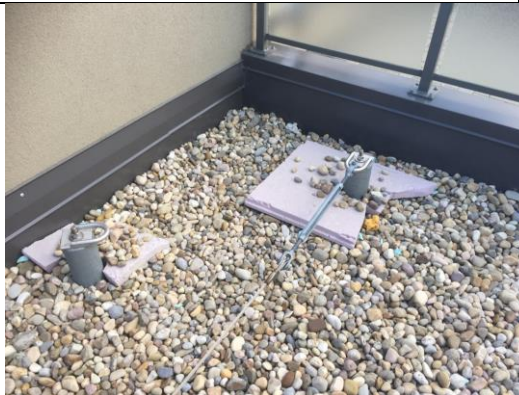
<p>Photo 5: Penthouse gravel ballast roof exposed insulation and without filter fabric.</p>

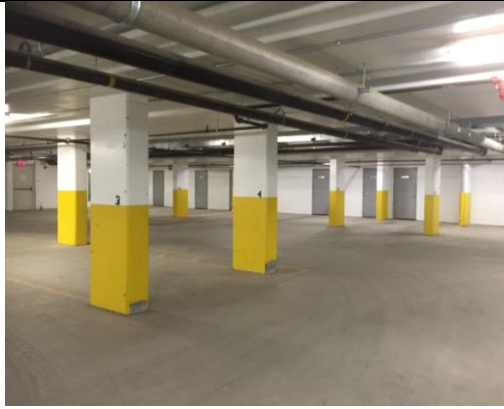
A6	Parking Deck Membrane	Traffic deck coating was not installed throughout the parkade. Exposed concrete slab has cracks that need to be repaired prior to installing new coating

<p data-bbox="870 659 1333 730">Photo 6: Parkade slab without traffic deck coating.</p>
A7	Retaining Walls	The west elevation has two locations, the north and south, with incomplete retaining walls.	
A8	Sprinkler Room	The sprinkler room at the parkade level is unsecured, and requires a new wall partition and secure door.
